THREE FOOT KOI with a Dramatic Water Garden Bottom 60,000 Gallons with a Multi-Million Dollar View

By: Larry Couture

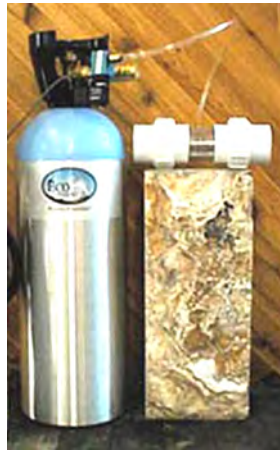
**Automated CO2
pH Control --
Without Sensors.**
